4. TITLE (and Subtitle) Phase I Dam Inspection Report National Dam Safety Program Duck Creek-State Wildlife Refuge #1 (MO 40063) Stoddard County, Missouri		5. TYPE OF REPORT & PERIOD COVERED Final Report

DUCK CREEK  
STATE WILDLIFE REFUGE - POND 1  
BOLLINGER AND STODDARD COUNTIES, MISSOURI  
MISSOURI INVENTORY NO. 40063

⑥ PHASE I INSPECTION REPORT  
NATIONAL DAM SAFETY PROGRAM,

Name of Dam	Duck Creek State Wildlife Refuge - Pond 1
State Located	Missouri
County Location	Bollinger and Stoddard Counties
Stream	Castor River
Date of Inspection	22 May 1979

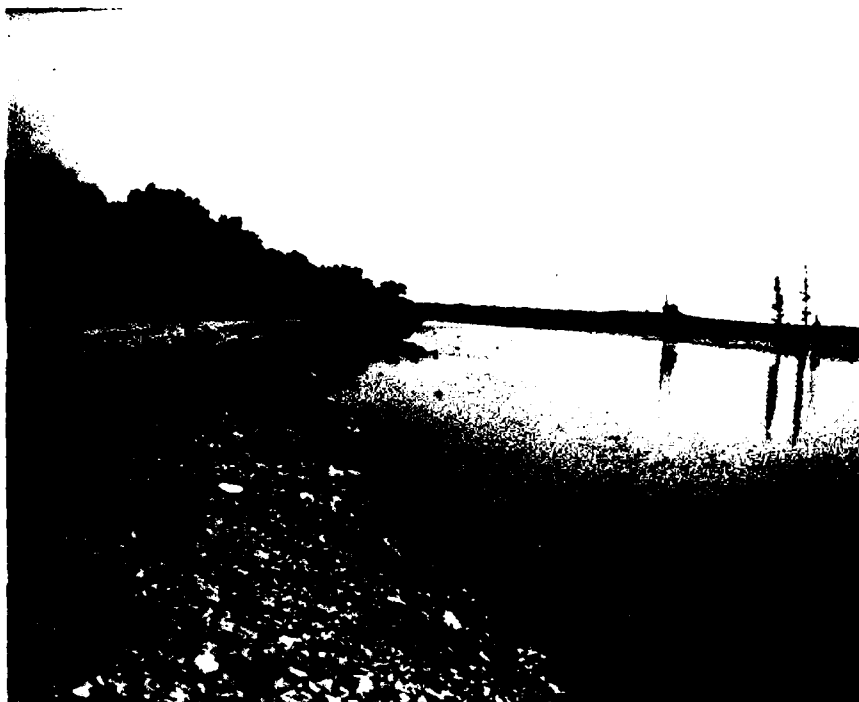
Photo 3: Lakeslope - Eastern Levee - Looking South from Section "Q"

e. Reservoir Areas. No wave wash, excessive erosion, or slides were observed along the shoreline of the reservoir. Riprap had been placed along all portions of the lakeslope of the reservoir (see Photos 3 and 5) except for the northern boundary.
